Office Memorandum • UNITED STATES GOVERNMENT

DATE: 23 September 1960

SUBJECT: TAILOR Transmitter Module Evaluation

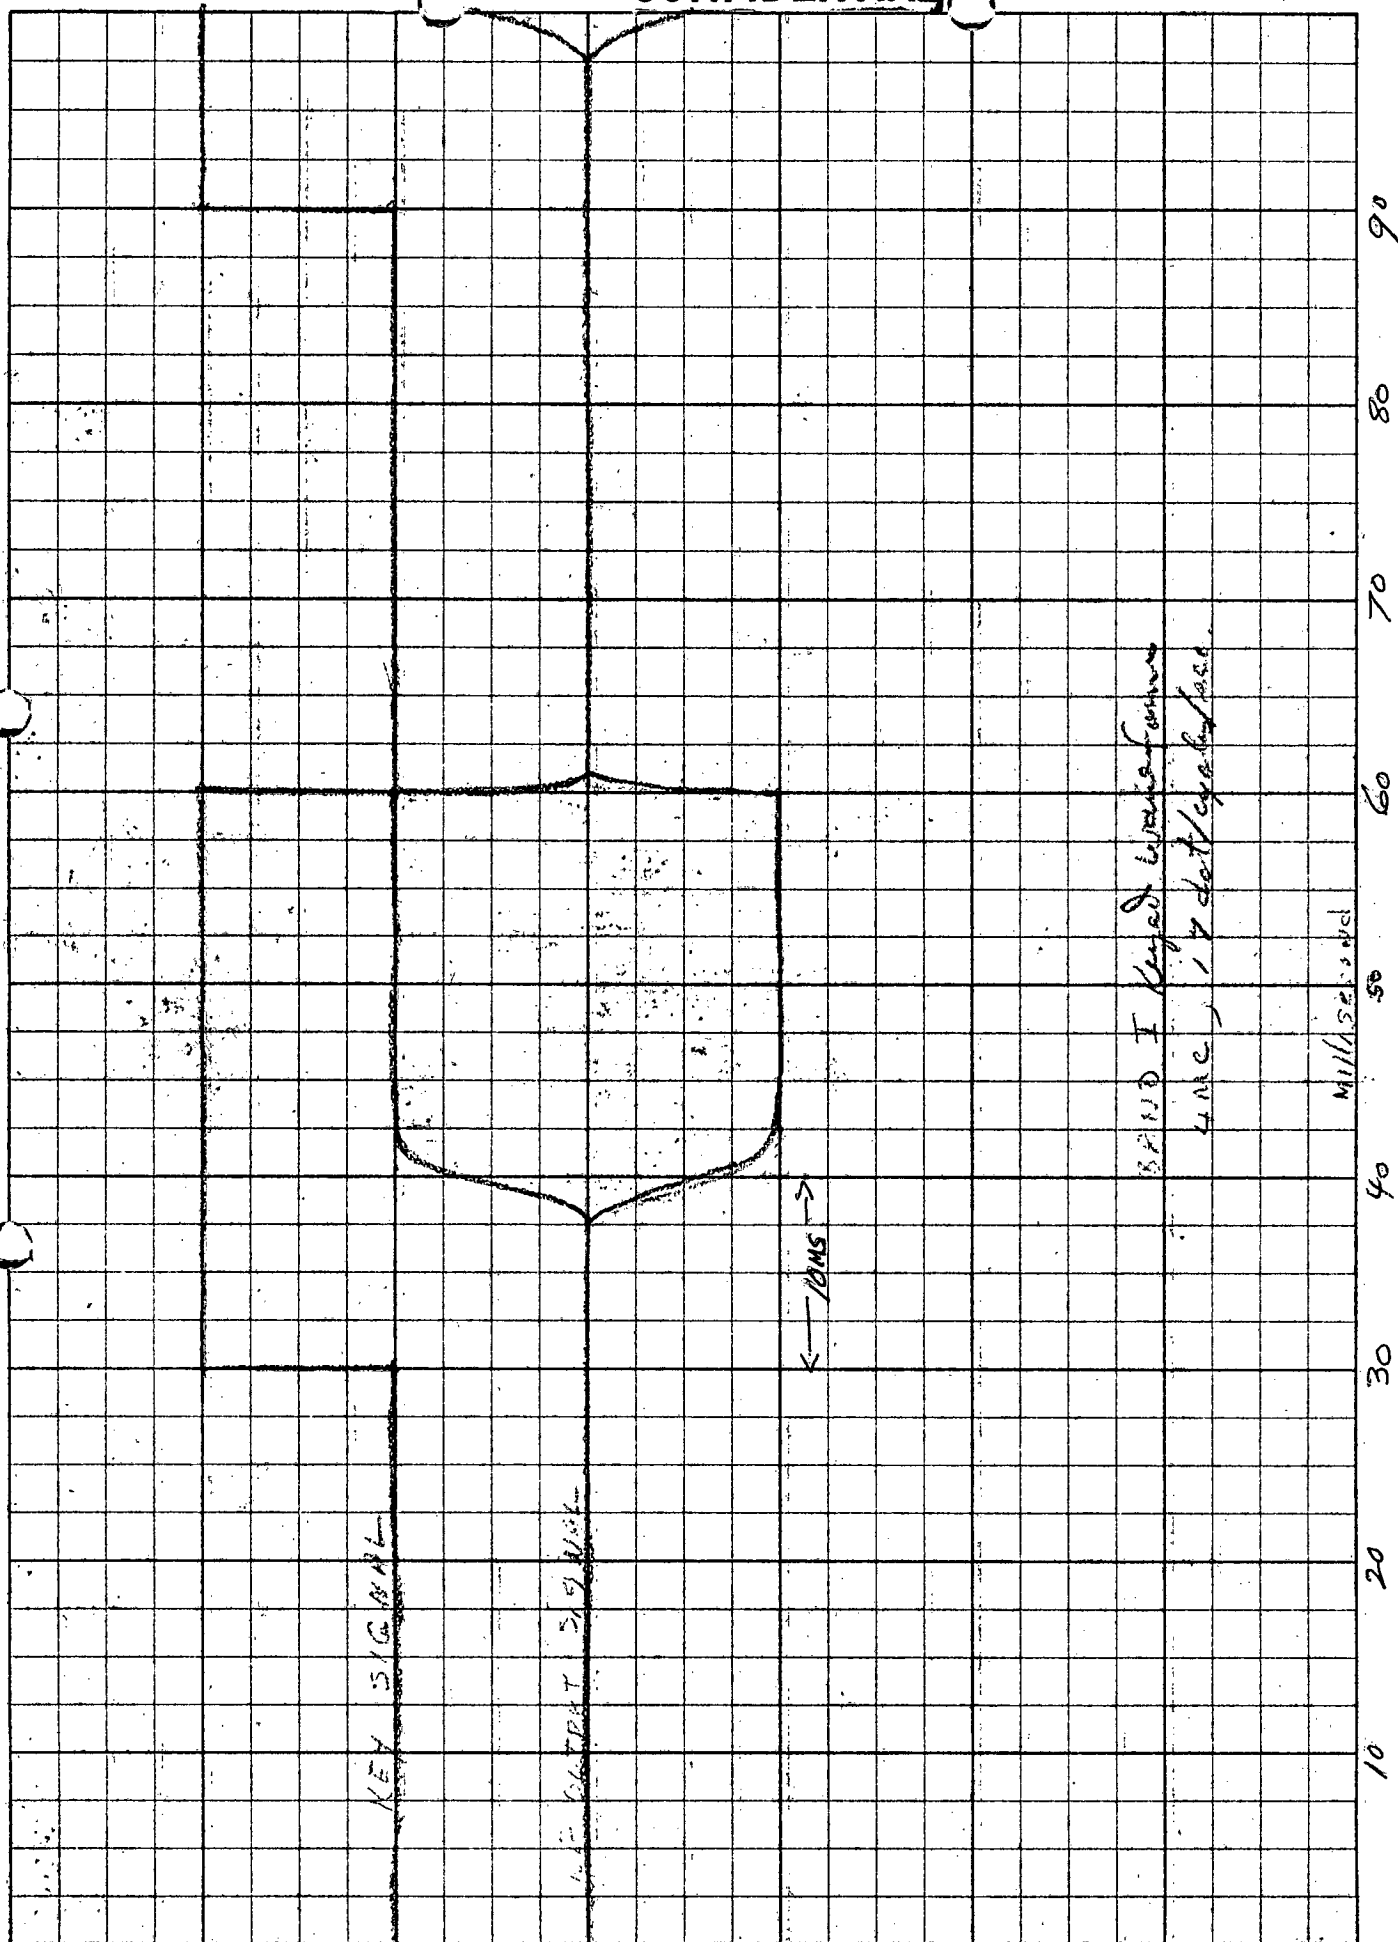
FIG. I

2. During the early phase of the evaluation, the test results showed serious shortcomings and as a result the tests were stopped. A summary of test data obtained, up to the time the tests were stopped, follow. Figures 1 and 2 show keyed waveforms typical of Bands I and III.

Keyed Waveform: Poor, 12 millisecond delay
